Quantification of the number of ascending salmon and trout in Piteälven 2015

Luleå 2016-08-23
Stefan Stridsman,
County Administrative Board of Norrbotten

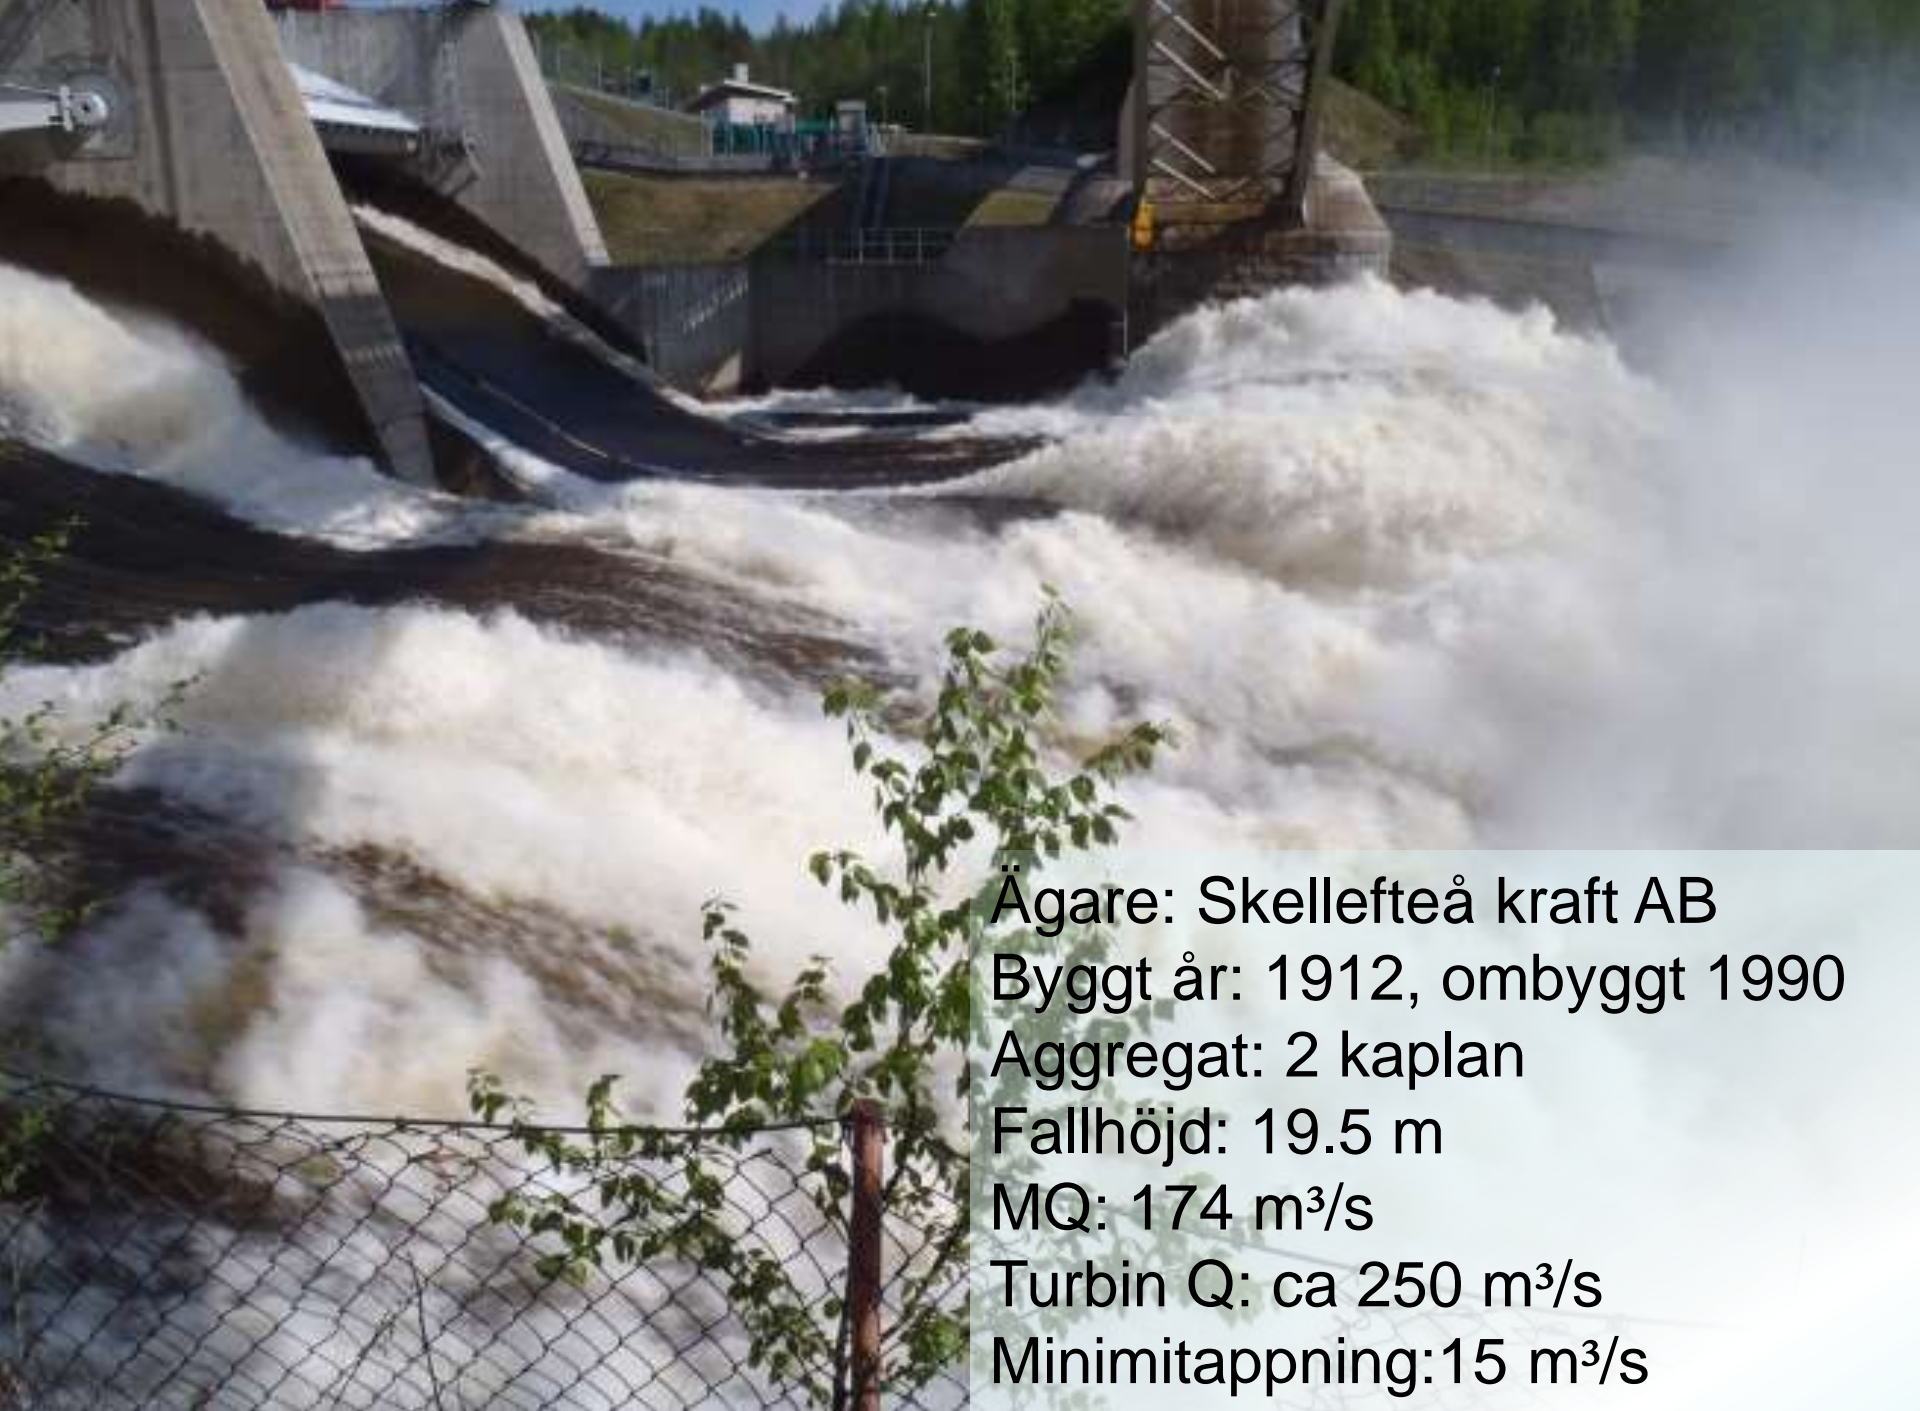
**Sikfors
HEP**

Ägare: Skellefteå kraft AB
Byggt år: 1912, ombyggt 1990
Aggregat: 2 kaplan
Fallhöjd: 19.5 m
MQ: 174 m³/s
Turbin Q: ca 250 m³/s
Minimitappning: 15 m³/s

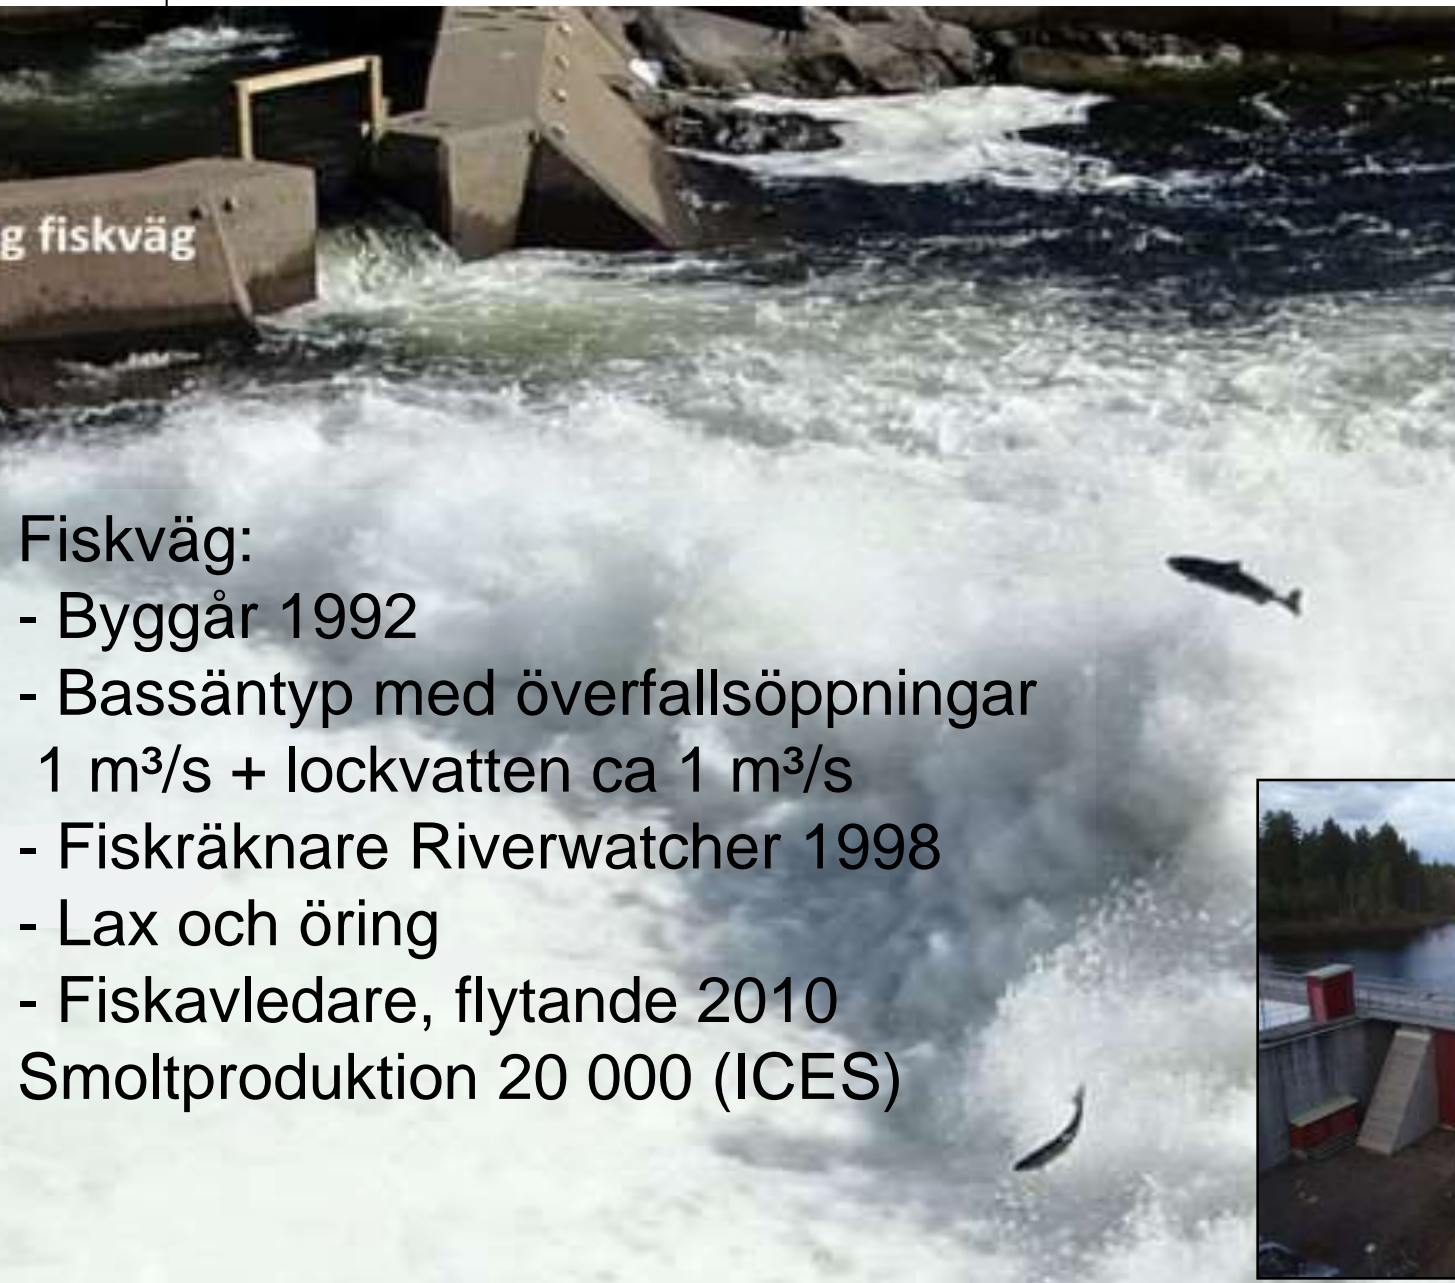
Fiskväg:

- Byggår 1992
 - Bassäntyp med överfallsöppningar
1 m³/s + lockvatten ca 1 m³/s
 - Fiskräknare Riverwatcher 1998
 - Lax och öring
 - Fiskavledare, flytande 2010
- Smoltproduktion 20 000 (ICES)

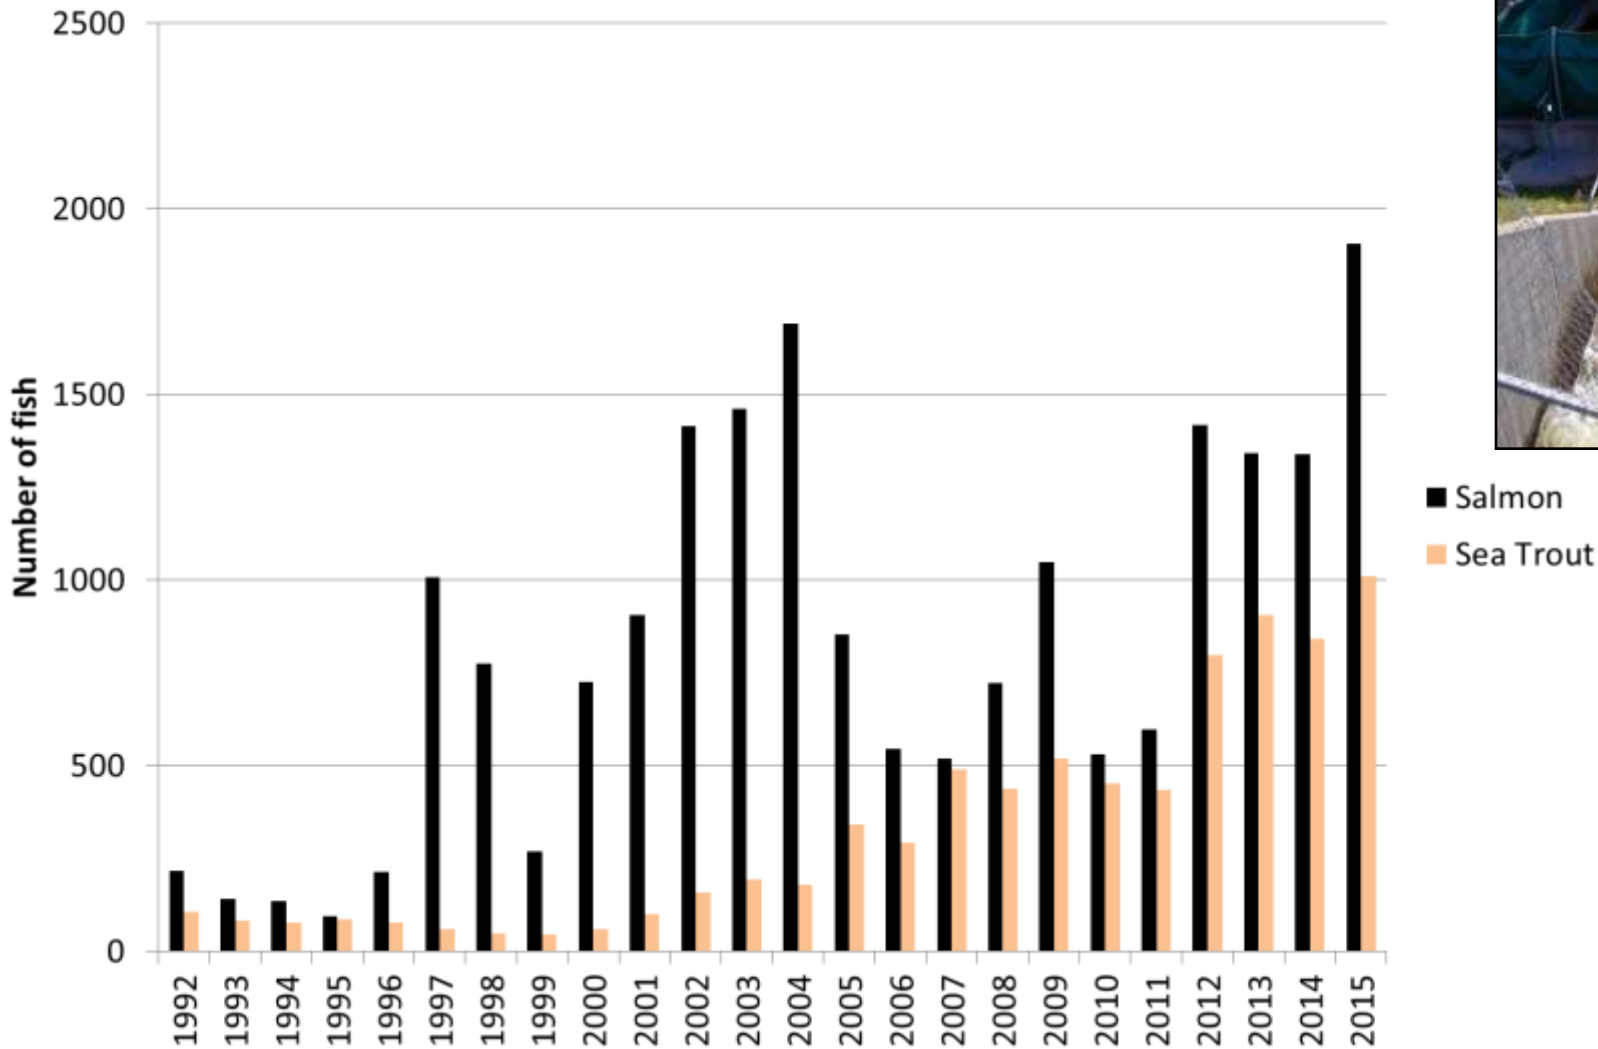
Salmon and trout passing the fishway Piteälven 1992-2015
